Doc. Title:	Submersible Pit Pump Case Study	Issue Date:	Feb 12 th 2021
Customer:	Various BOP Municipality Waste Water Dept.	Author	D Bell

Submersible Pump Discharge Flange & Foot Piece Leakage

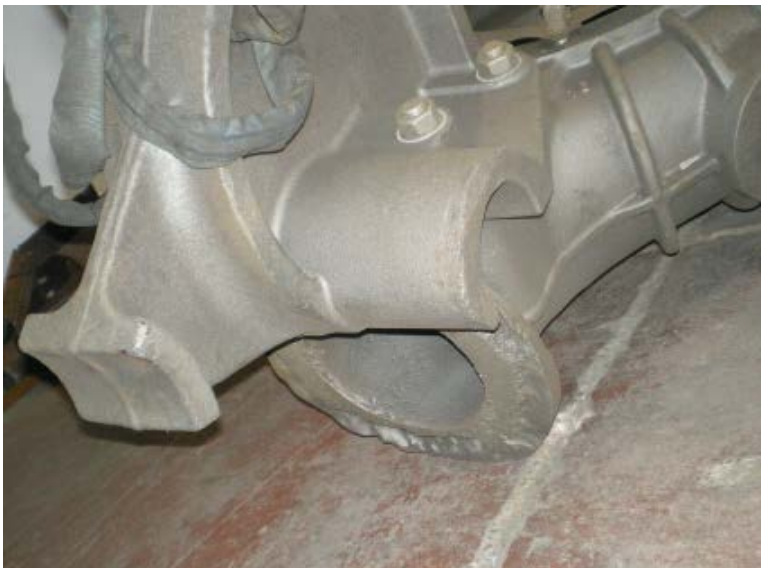
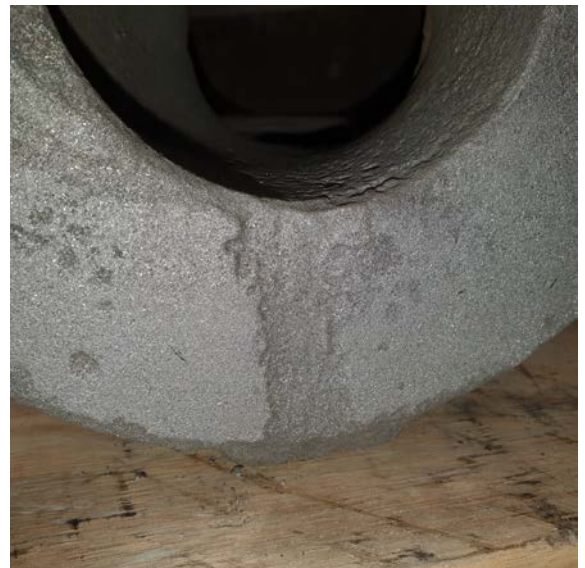
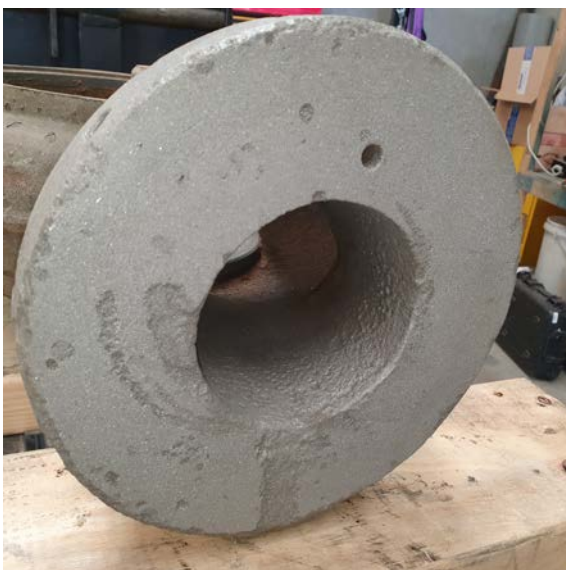
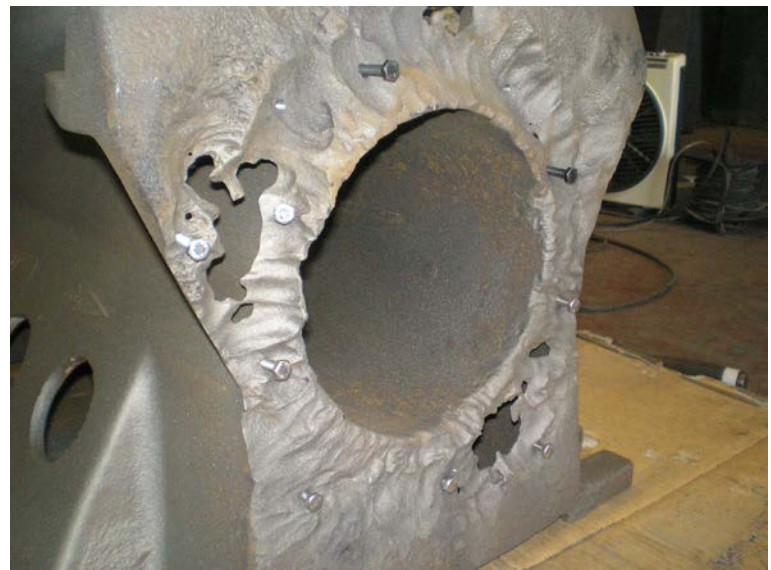
1. Vocation & Current Issues. Down-Hole Component Corrosion – Erosion is largest single cause of Submersible Pit Pump Leakage leading to massive pump inefficiencies and energy waste due to constant recycling of waste fluid back into collection pit. See below for graphic examples of such problems.

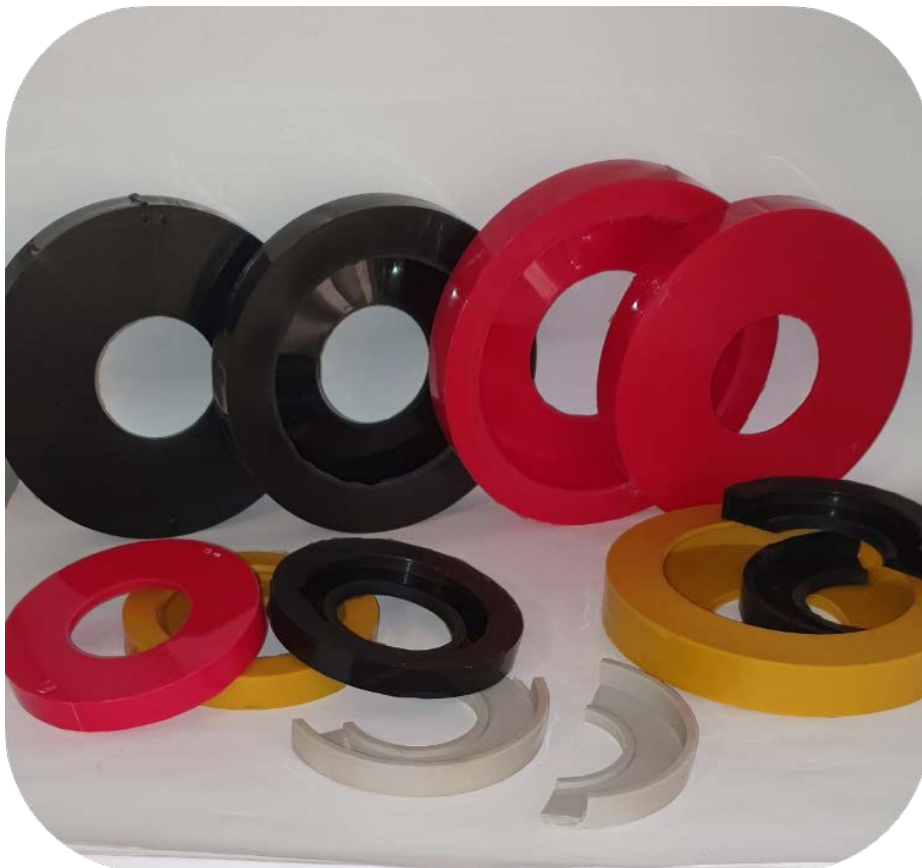
Selection of "Flange Sock"[™] in Shore 60 / 80 / 90

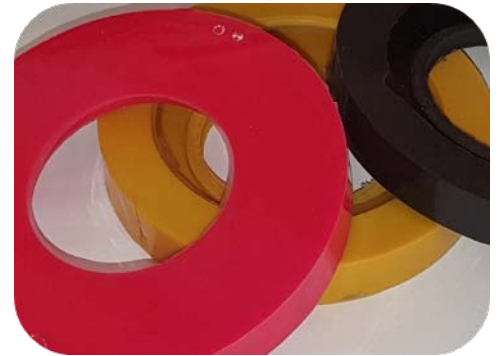
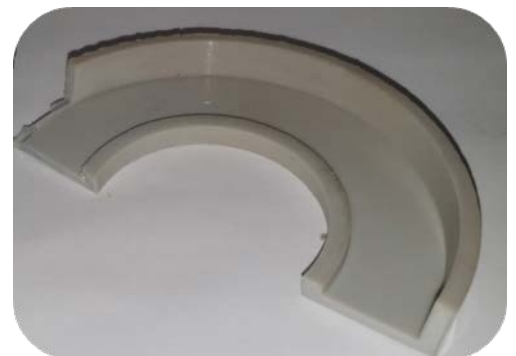
Optional Internal upset to seat in seal pocket of High Head FLYGT Pumps

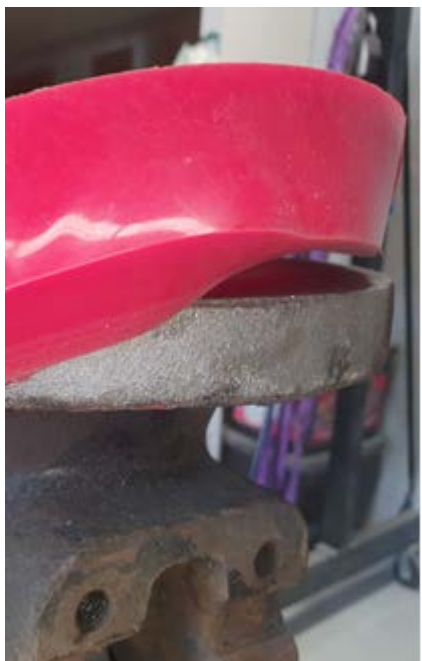
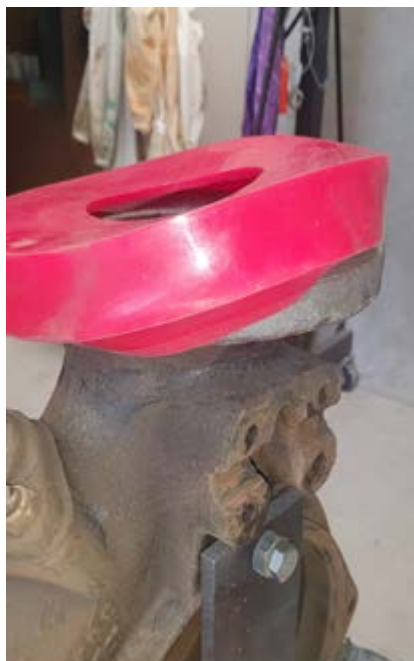
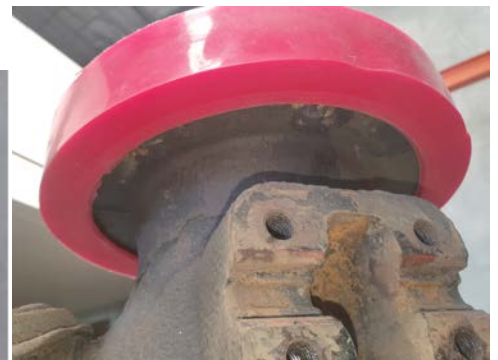
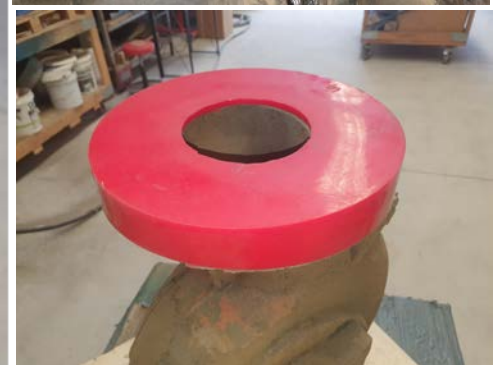
OPNZ "Retention Skirt" wrapping around back of flange

- a. “Flange Sock”™ fitted over discharge flange of pump, the flange sock uses a unique retention skirt that folds around the back of the flange, preventing the seal from being displaced or “knocked” off of the flange during reinstallation of the pump back in the pit. The soft / flexible property of the Shore A 65 elastomer conforms to surface variations in both the pump flange face and footpiece face to enhance sealing and prevent leakage. The “Flange Sock”™ solution is ideal for reduced down time intervention as a leaking pump can be raised from the pit, the pump quickly washed down and the “Flange Sock”™ installed over the discharge flange and the pump is then lowered back into the pit onto its footpiece with an approximate < 20 Minute time window.

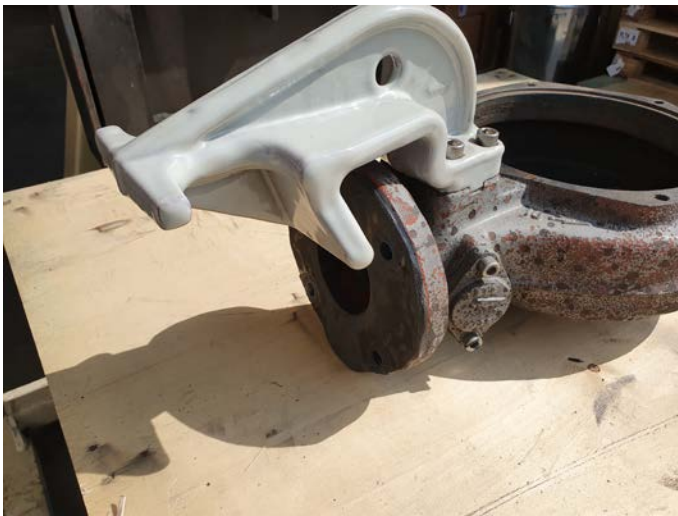
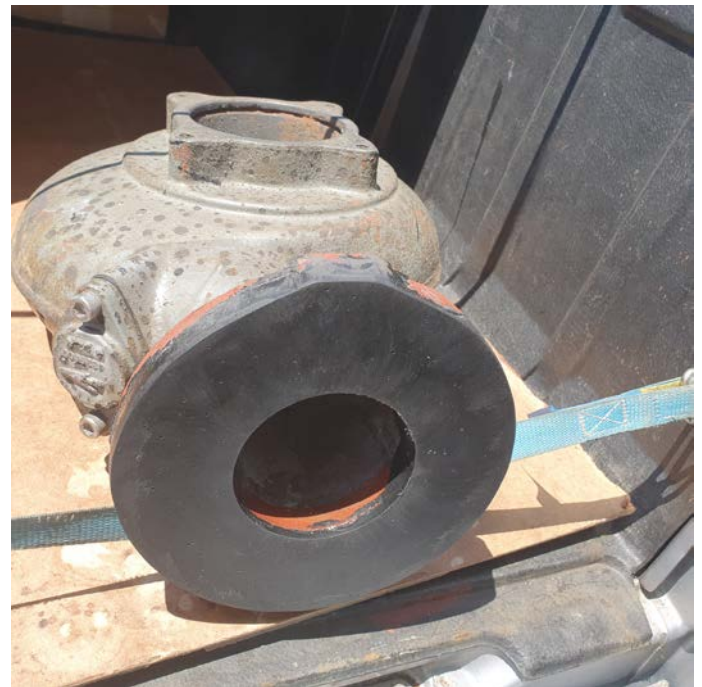
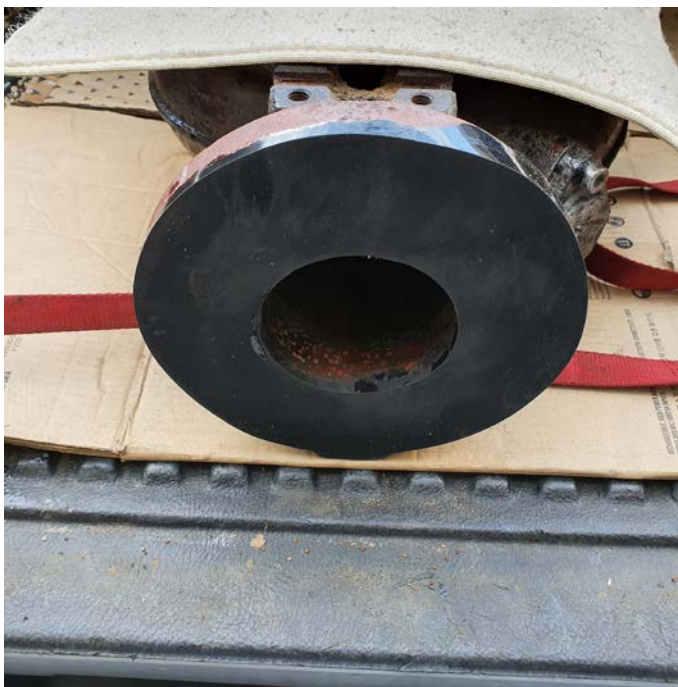
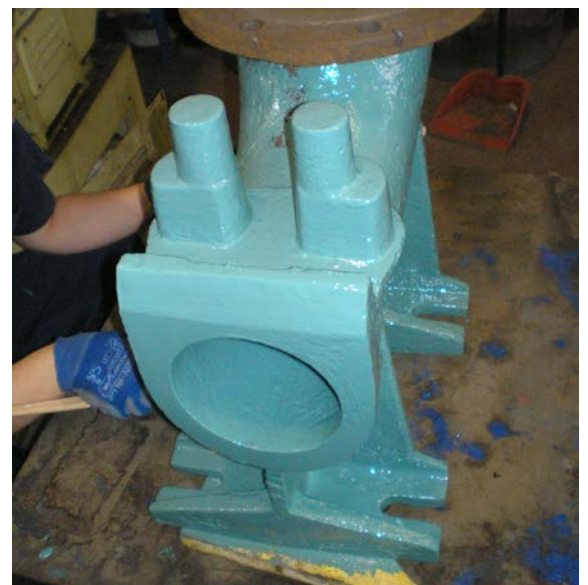
- a. Significant reduction in Pump Run Time resulting in >30% energy savings per pit.
- b. Instant cessation of leakage visible from Pit top when treated pump turned on.
- c. Prolong Service life of worn Foot pieces and Pump Volutes
- d. Significant life extension (> 90%) of pump & pit components when treated from new, especially pump impellers and volutes used in High Grit / Sand Load pump stations
